Mapping Mangawhai Spit¹

Summary prepared by Phil McDermott and Terry Hume

Mangawhai Matters Inc

1. Auckland University (2024) “Topographic mapping of Mangawhai sand spit and development of a draft framework for monitoring future changes” Professor Mark Dickson, Assoc. Prof. Murray Ford, Dr Emma Ryan

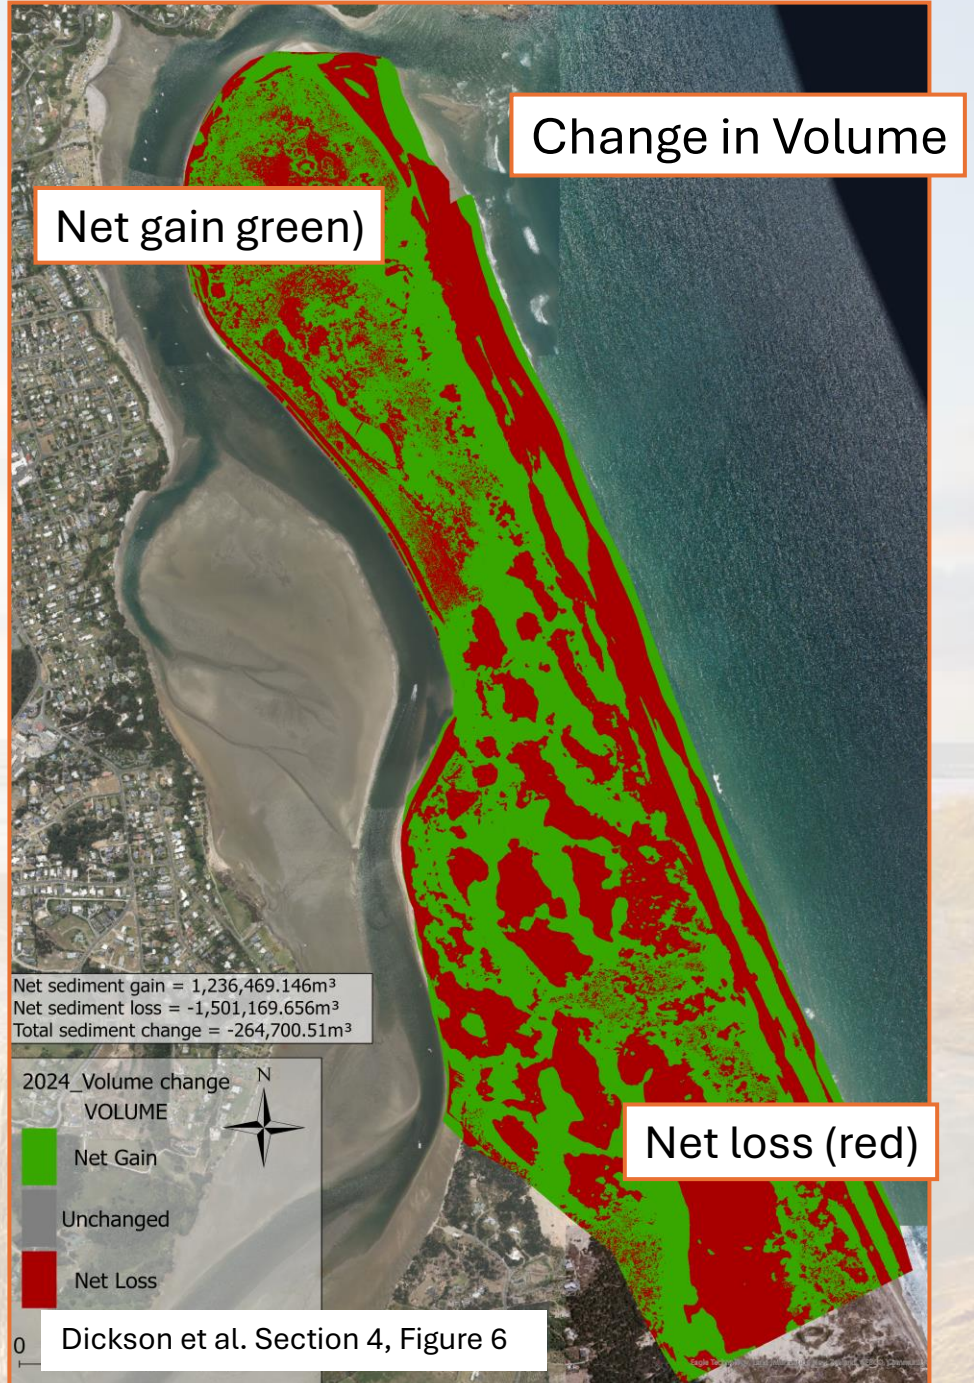
5 Changes in Spit Morphology, 2018-2024

- Changes from 2018 to 2024:
 - The low-lying interior has not changed appreciably
 - Erosion of ocean shore from westward dune movement
 - Big dune has moved west 10-25m and decreased in elevation
 - Harbourside erosion up to 15m in places
- The result:
 - a six year net loss of around 264,700m³ of sand after replenishment by dredging (c.1.8% of total volume)

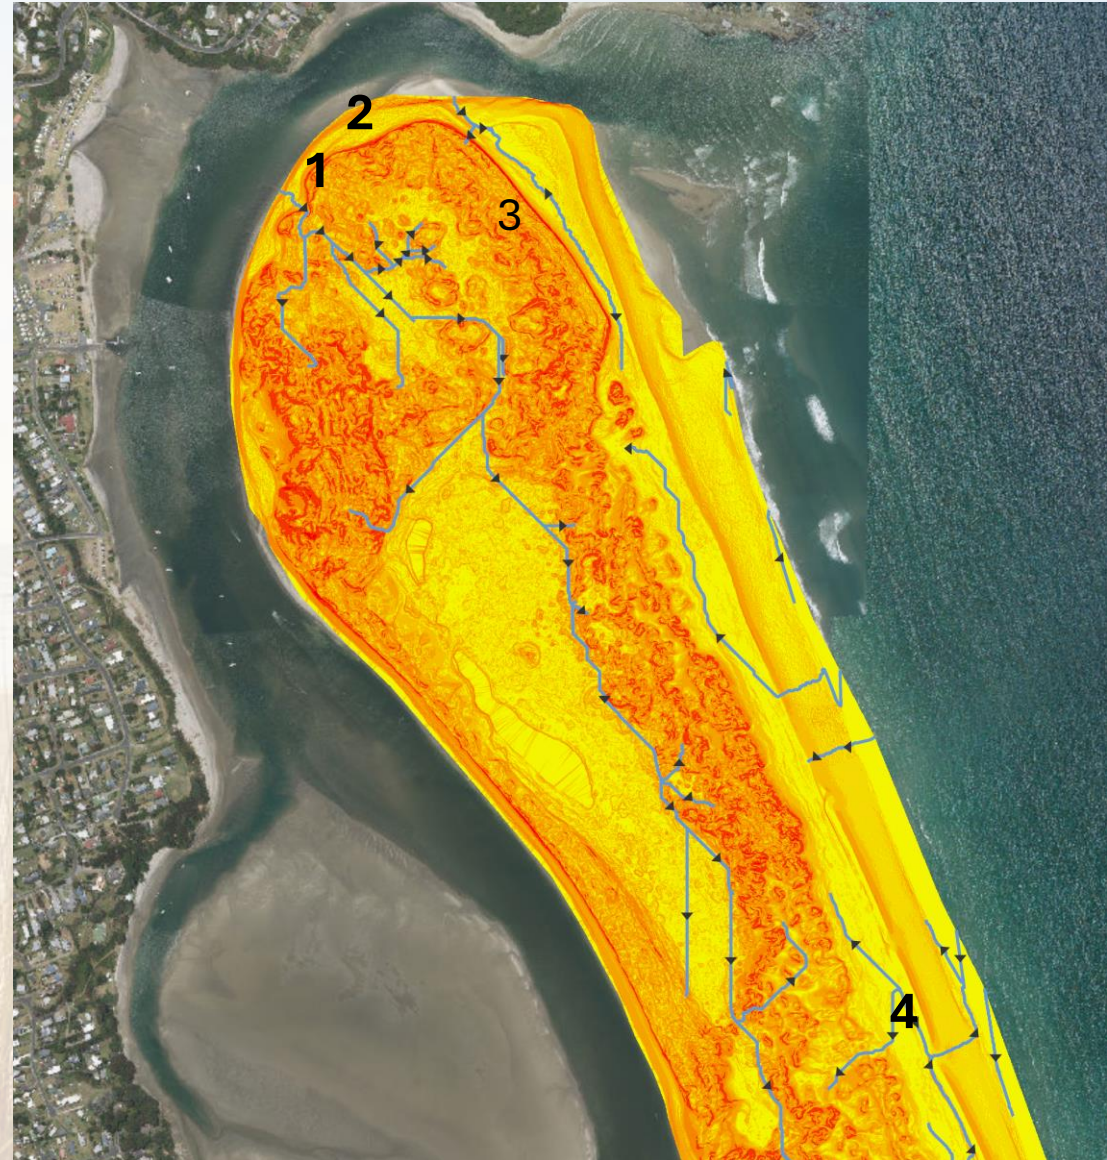
7 Low Points, Pathways, & Areas at Risk

- Greatest potential for breaching Point 4 where spit is narrowest
- Northern part of spit (points 1 and 2) are vulnerable
- Northern portion of spit – site of previous breach – at significant risk

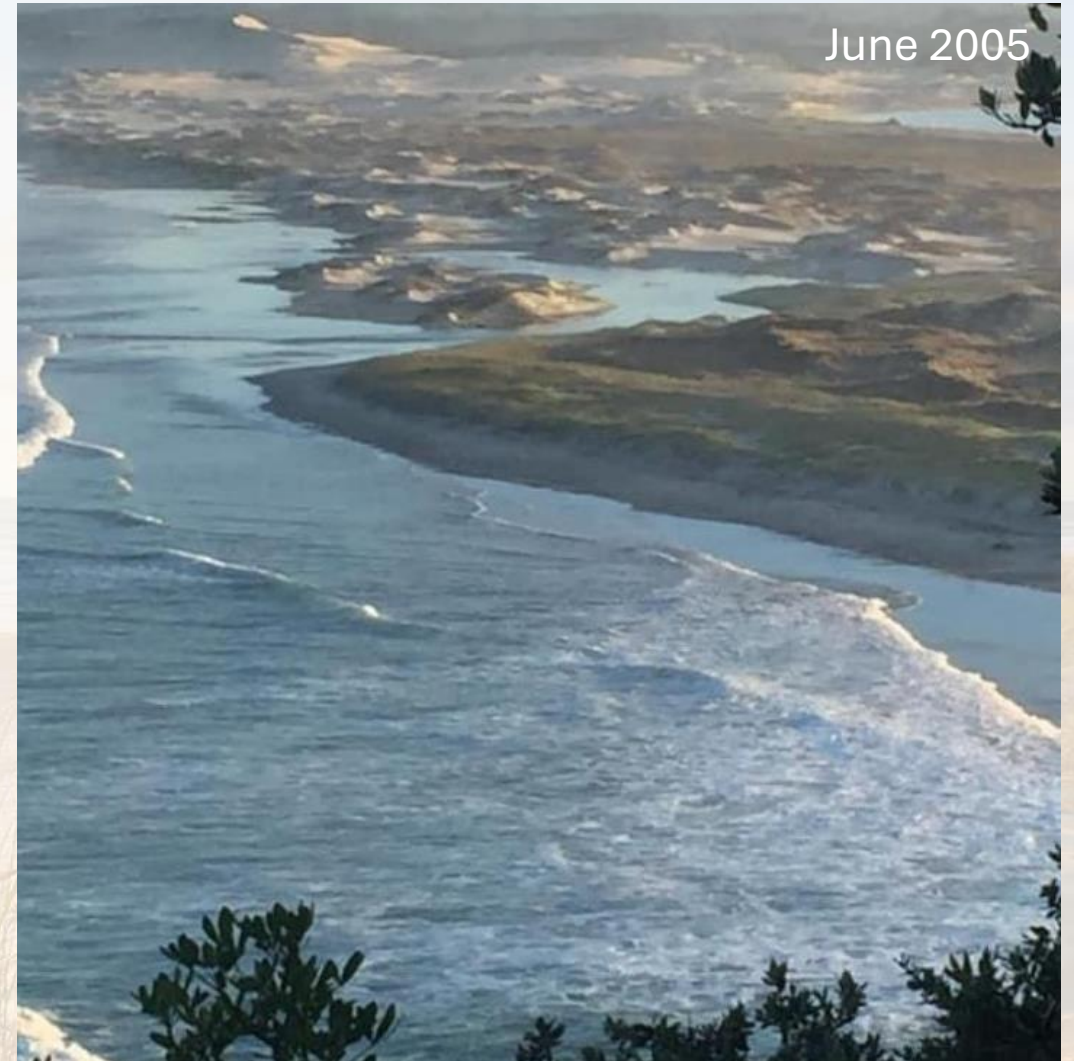
8 Potential for Inundation

Bathtub modelling – floods areas of the spit based on slopes and elevation

Based on current spit morphology, two sets of flooding scenarios:

Sea Level Rise: Typical annual storm unlikely to inundate the interior with SLR projections to 2040 but likely to do so by 2080.

Extreme storms: 1% Annual Return Interval conditions (cf 1978) see large portions of the spit inundated and breaching a prospect.

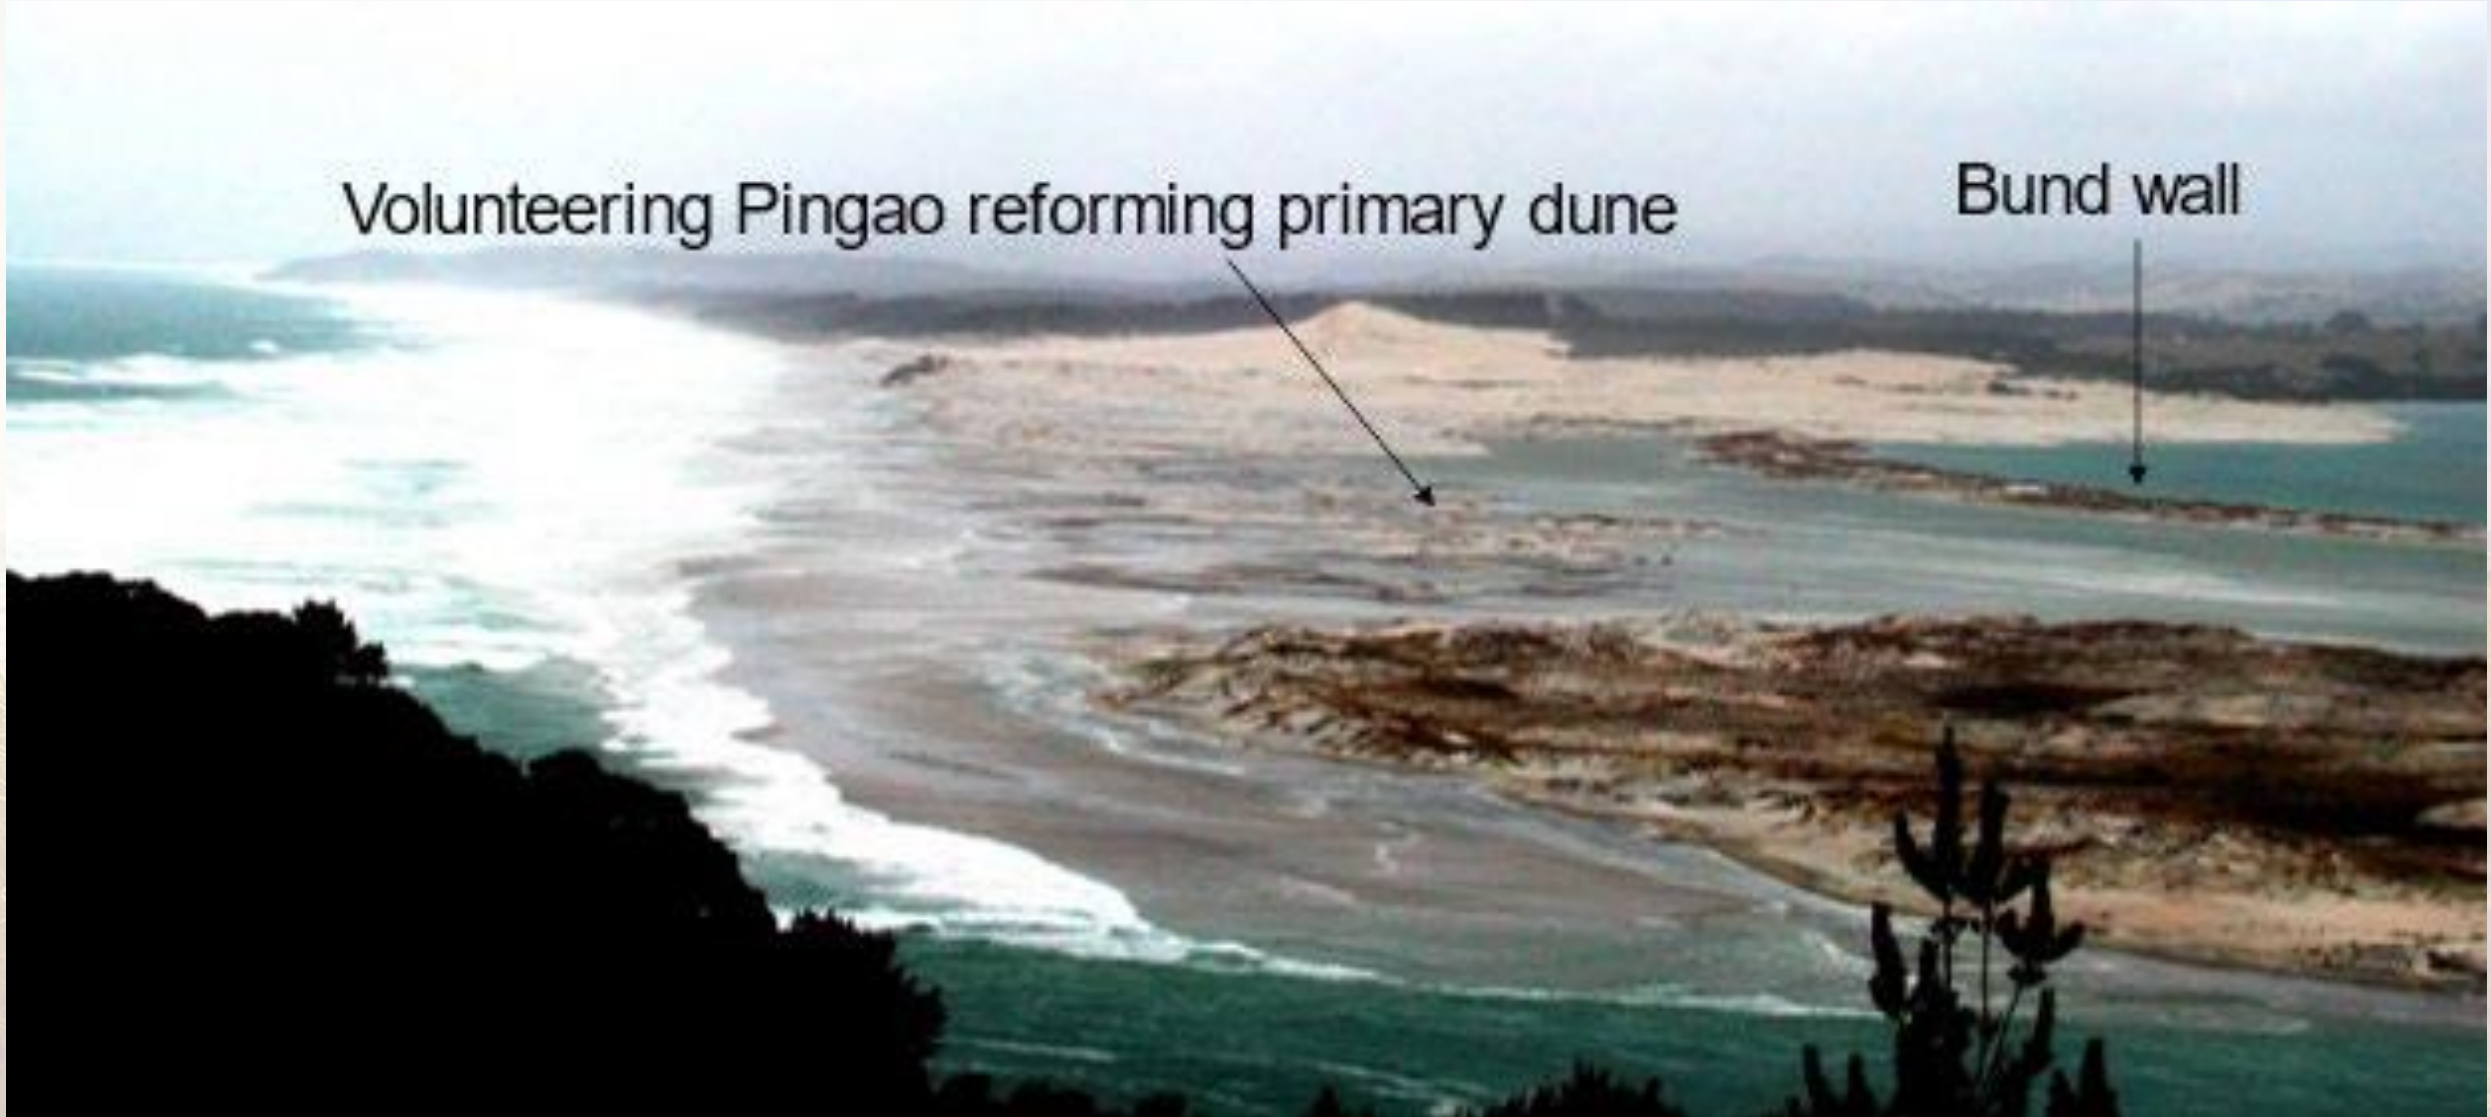
11 Inundation from the Ocean, 2005

Volunteering Pingao reforming primary dune

Bund wall

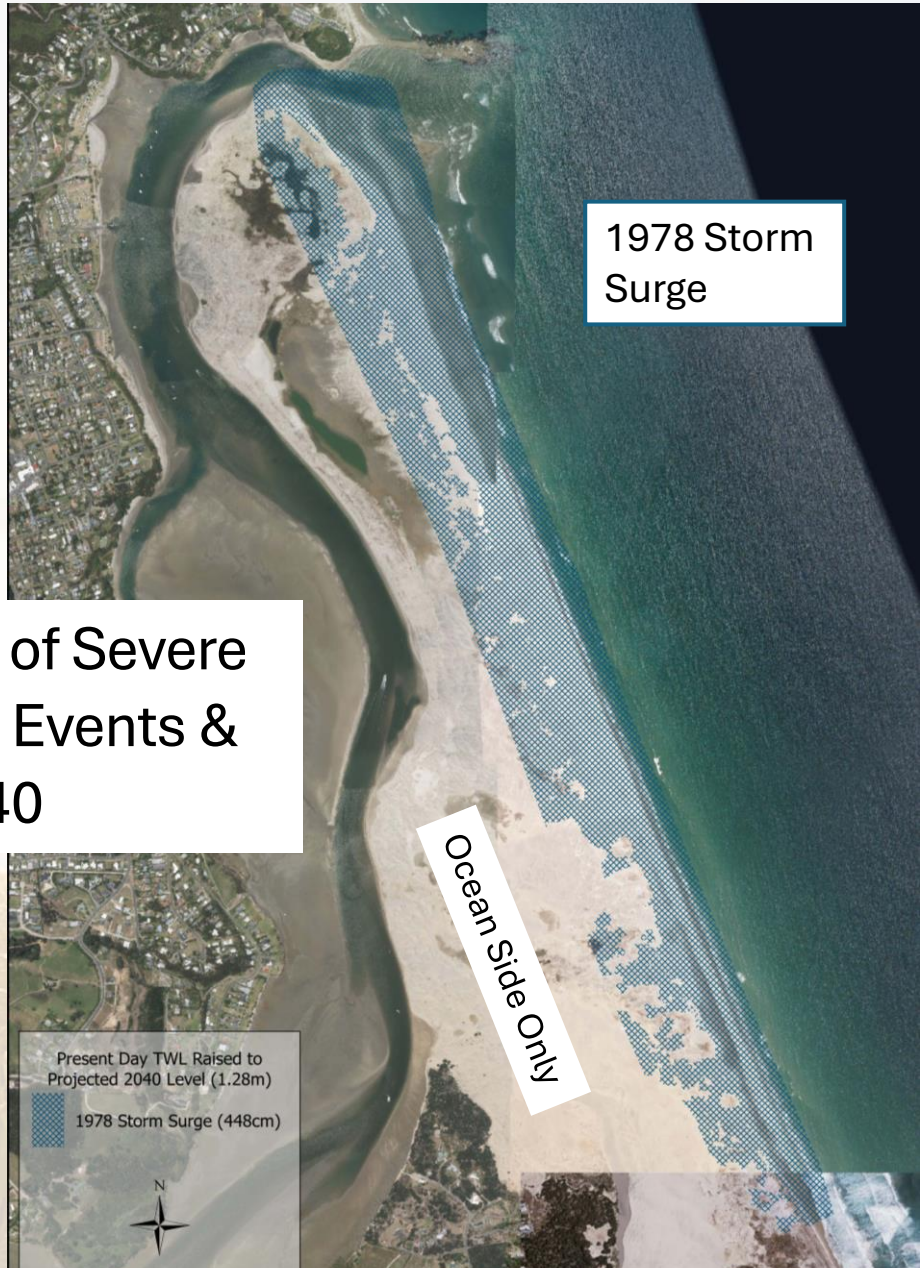
Based on Dickson et al. Section 7, Figure 13

1978 Storm Surge

Ocean Side Only

Present Day TWL Raised to Projected 2040 Level (1.28m)
1978 Storm Surge (448cm)

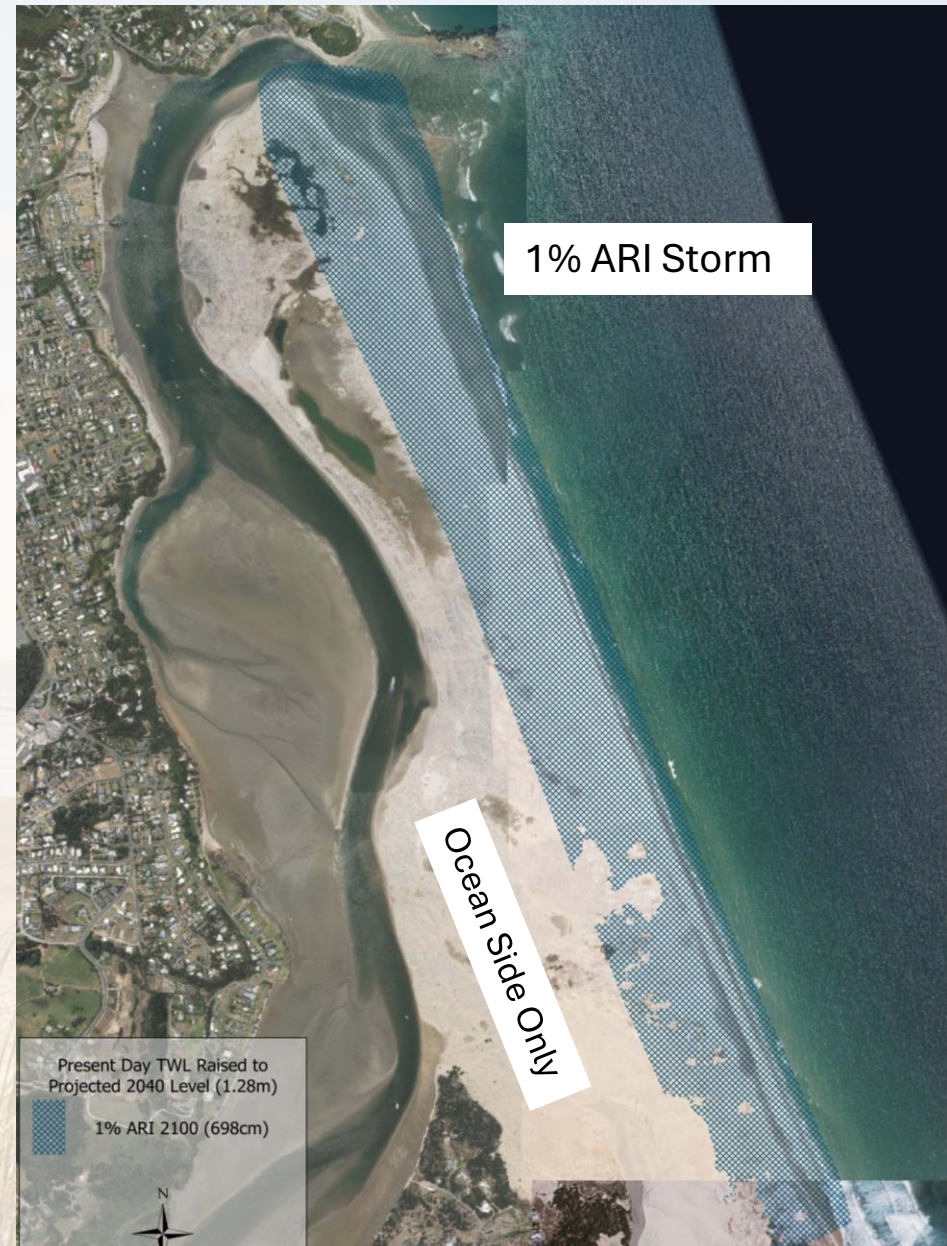
Based on Dickson et al. Section 7, Figure 14

1% ARI Storm

Ocean Side Only

Present Day TWL Raised to Projected 2040 Level (1.28m)
1% ARI 2100 (698cm)
